# VERMONT TECH

RANDOLPH CENTER CAMPUS

## FACILITIES CONDITIONS ASSESSMENT

AUGUST 20, 2018

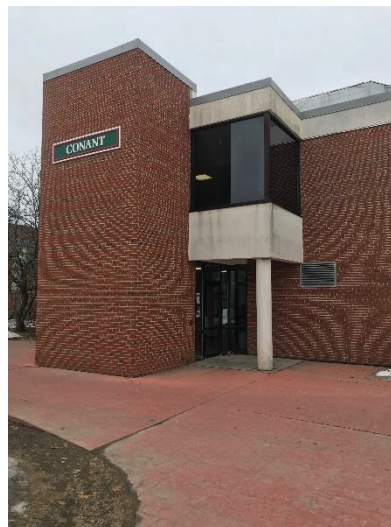
- Structure: CMU bearing wall with steel framed concrete floor slabs and structural acoustic roof deck (Tectum).
- Foundation: Cast-in-place concrete.
- Walls: Brick veneer with CMU backup.
- Roof:  
Flat: White PVC membrane (Trocac).

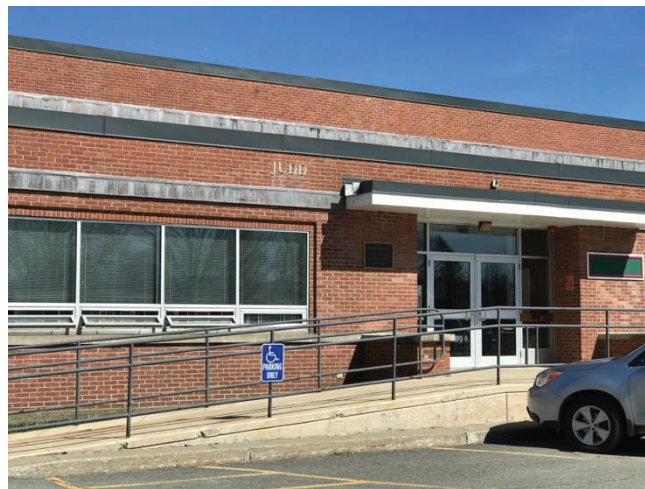
- Structure: CMU bearing walls with steel roof framing.
- Foundation: Cast-in-place concrete.
- Walls: Brick veneer with CMU backup.
- Roof:
  - Flat: Fully adhered black .090 EPDM membrane installed in 2017.
  - Sloped Canopy Roofs: Standing Seam Metal Roofing installed in 2017.

USE: This academic building includes faculty offices and a multi-purpose event space (Old Gym) with bleacher seating. The campus bookstore is on the east side of the building.

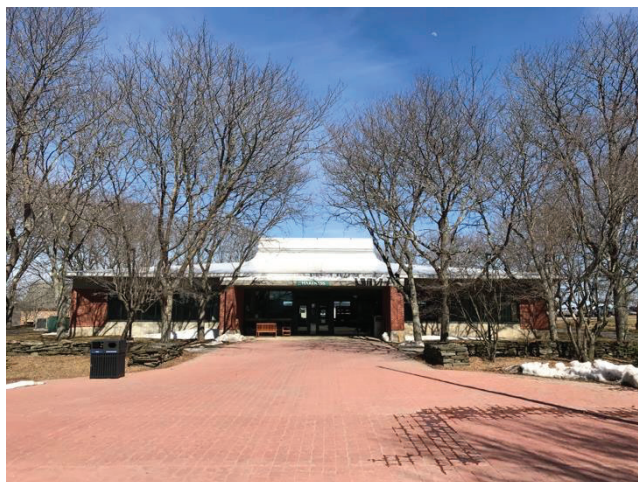
- Structure: Brick bearing walls with wood roof framing.
- Foundation: Cast-in-place concrete.
- Walls: Brick exterior and brick or GWB interior.
- Roof:  
Flat: Fully adhered white .060 EPDM membrane (Carlisle) installed in 2003.

USE: This academic building includes the library, offices and meeting rooms.

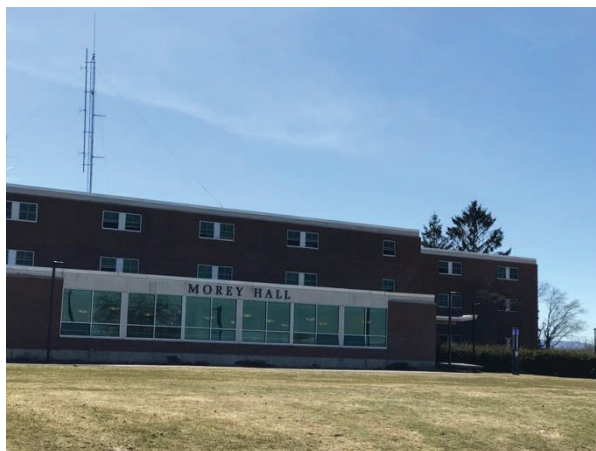
- Structure: CMU bearing walls with concrete plank floor and roof slabs.
- Foundation: Cast-in-place concrete.
- Walls: Brick veneer with CMU backup.
- Roof:  
Flat Roof: Mechanically attached reinforced black .060 EPDM membrane installed in 2013.

USE: This residential building includes student living spaces, bathrooms, shower rooms, lounges and laundry rooms. The Dining Hall, Kitchen, Radio Station, Student Affairs and Student Council are located on the first floor.
