Facilities Conditions Assessment

KEENAN HALL

CONSTRUCTED: 1967

LAST RENOVATED: 1999

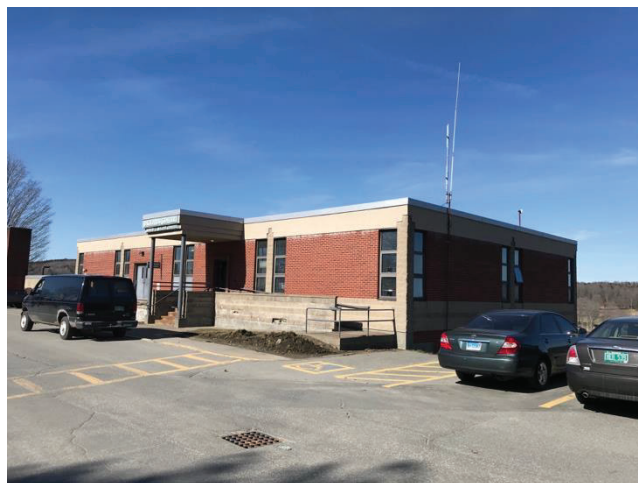
Construction:

- Structure: Steel. Precast concrete roof panels at Heating Plant.
- Foundation: Cast-in-place concrete.
- Walls: Brick and CMU veneer with metal framing and GWB interior finish.
- Roof:
Flat: Ballasted Carlisle .060 EPDM membrane installed in 2015.

USE: This building includes workshop space and offices for facilities and maintenance operations. The Heating Plant is located on the Lower Floor in this building.

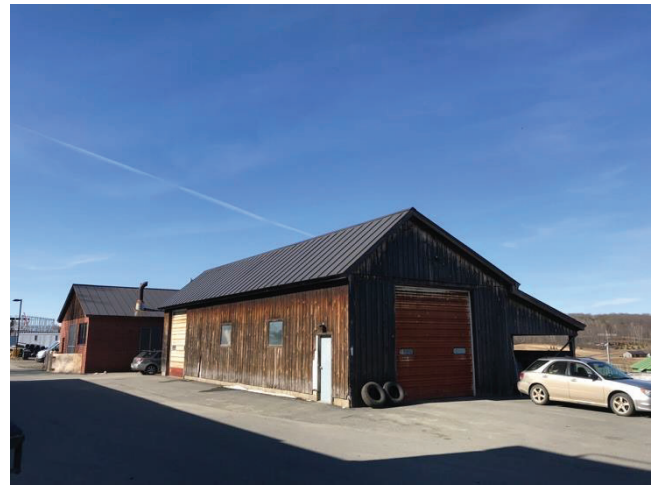
- Structure: Wood framing.
- Foundation: Cast-in-place concrete.
- Walls: Wood studs with vertical wood board exterior.
- Roof:
Sloped: Standing seam metal.

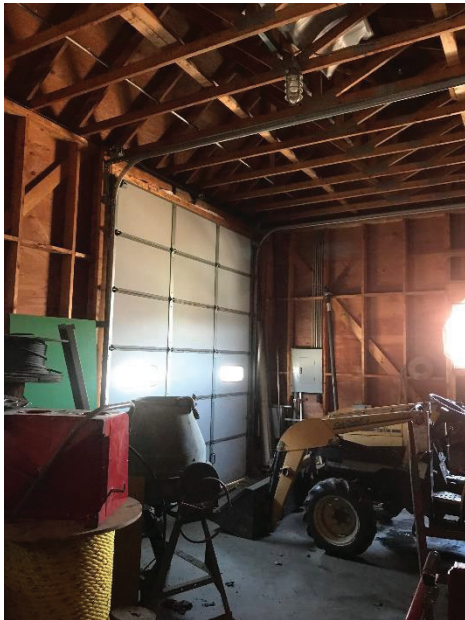
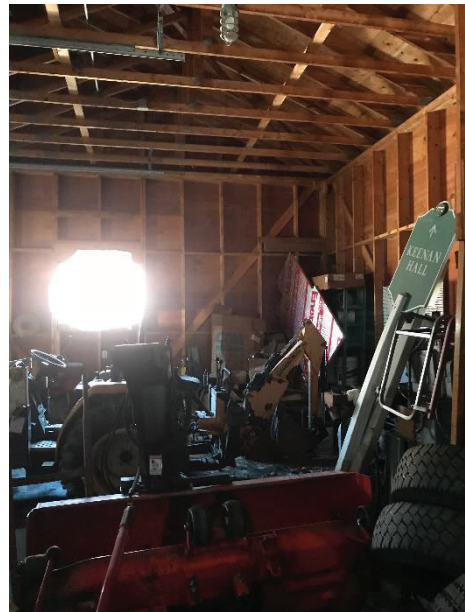
INTERIOR:

- The concrete floor is in good condition.
- There are no interior finishes.

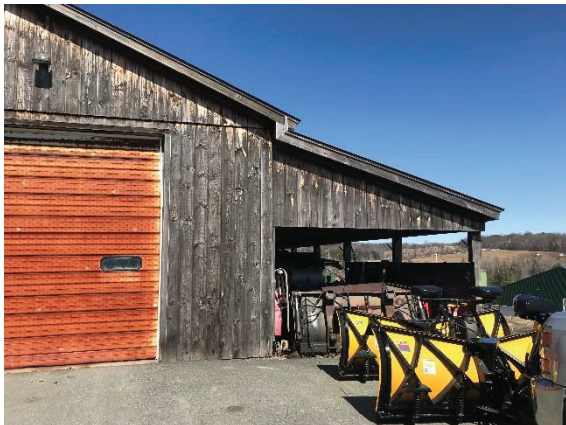
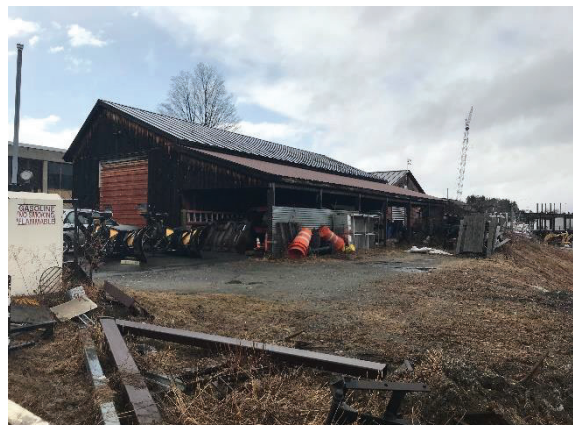
EXTERIOR:

- Unfinished weathered wood board siding is in fair condition. Replace deteriorated and damaged boards on the west side.
- Fixed single glazed windows are in fair condition.
- Painted steel door is in good condition. The wood frame is in poor condition, repair or replace and paint to match. Replace the knob style lockset with lever style.
- The overhead doors are rusted on the exterior. The tracks are in good condition. Replace both overhead panel doors.

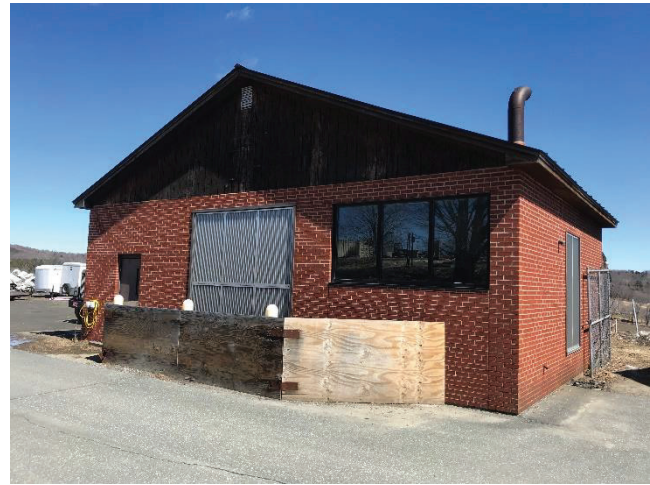
- Structure: Load bearing CMU with wood trusses.
- Foundation: Cast-in-place concrete.
- Walls: Brick veneer with CMU backup.
- Roof:
Sloped: Standing seam metal.

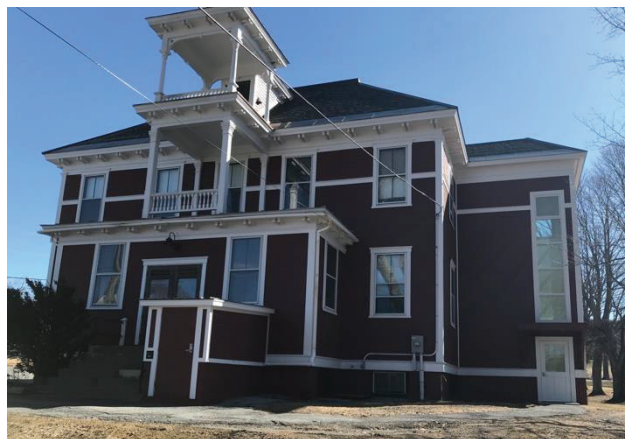
- Structure: Wood framed.
- Foundation: Cast-in-place concrete.
- Walls: Wood studs with gypsum wallboard interior and wood clapboard siding exterior.
- Roof:
Sloped Roofs: Asphalt shingles with a flat lock metal snow belt.

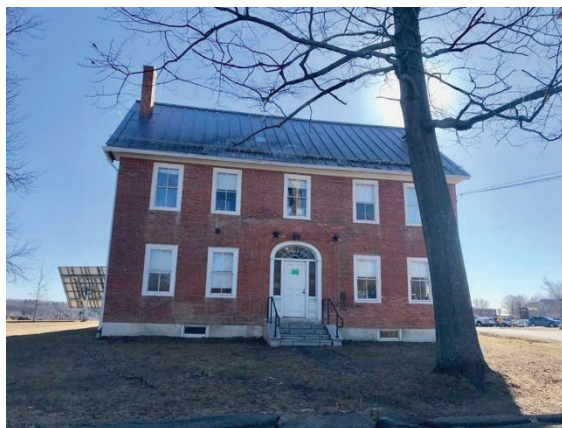
- Structure: Brick masonry bearing walls w/ wood rafter roof at original house.
Wood framed walls w/ wood rafters at east addition.
- Foundation: Cast-in-place concrete at east addition & stone foundation with cut stone veneer at original house.
- Walls: Brick veneer with wood framed backup and gypsum wallboard interior.
- Roof: Sloped Roofs: Standing seam metal roofing installed in 2011.

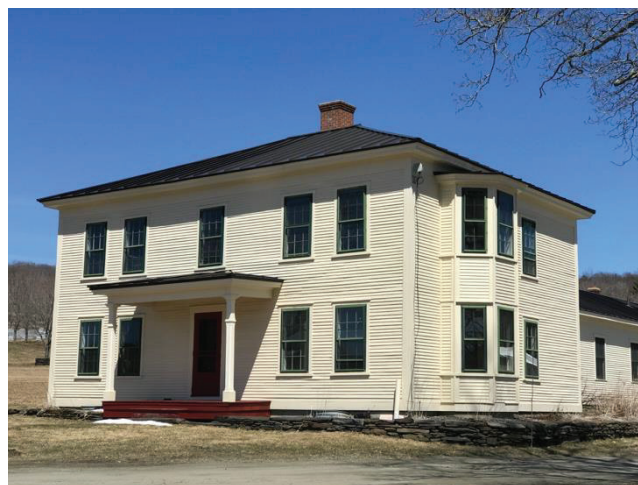
- Structure: Wood framed.
- Foundation: Cast-in-place concrete.
- Walls: Wood studs with gypsum wallboard interior and wood clapboard siding exterior.
- Roof:
Sloped Roofs: Standing seam prefinished metal.

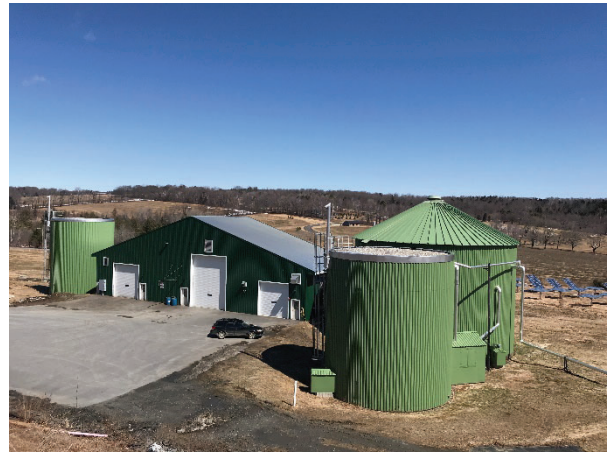
- Structure: Steel.
- Foundation: Cast-in-place concrete.
- Walls: Metal stud with corrugated metal wall panel interior and exterior.
- Roof:
Sloped: Corrugated Metal.

- Floors: Sealed concrete is in good condition.
- Walls: prefinished corrugated metal panels are in good condition.
- Ceilings: prefinished corrugated metal panels are in good condition.

- Prefinished corrugated metal siding is in good condition
- Aluminum fixed windows are in good condition.
- Insulated steel doors and overhead doors are in good condition.
- Prefinished perforated metal soffits are in good condition.
- Some sections of prefinished metal eave trim are missing, replace to match.

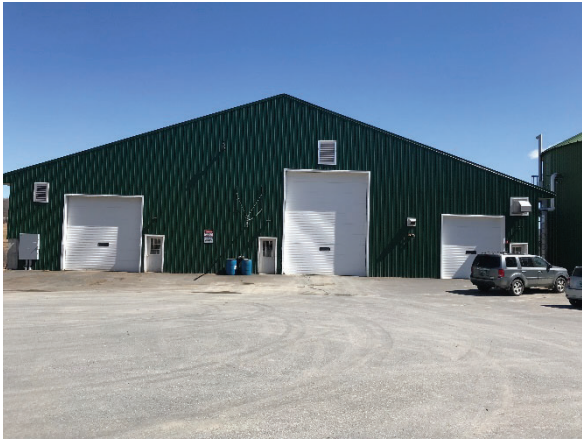
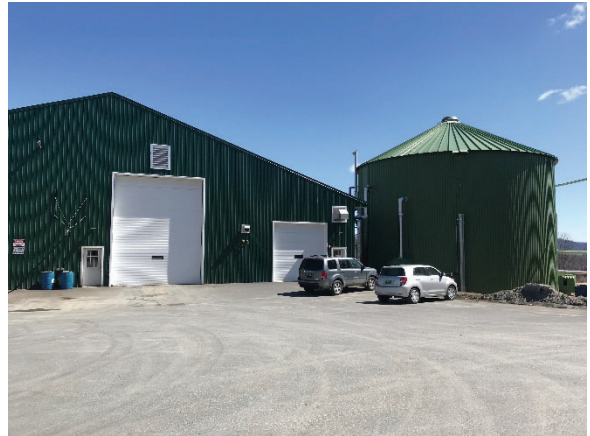
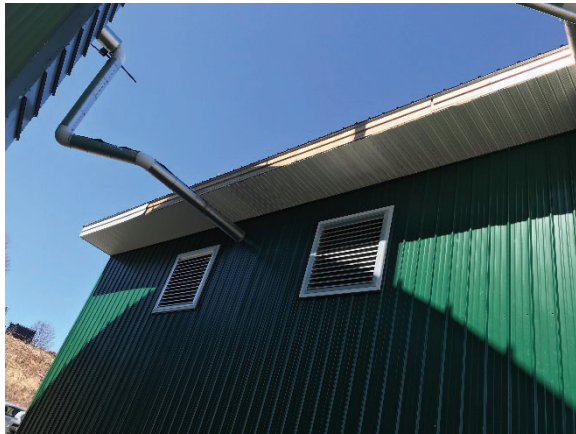
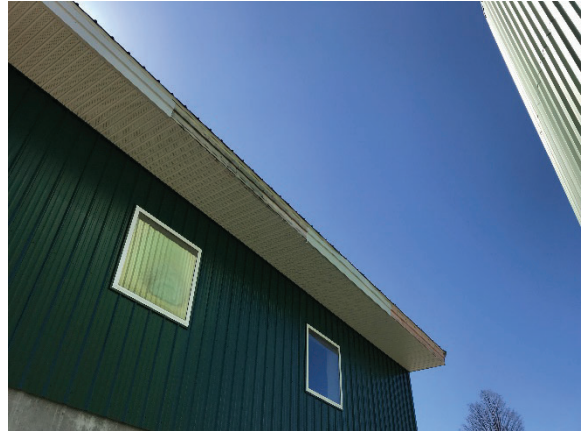
EXTERIOR:

Roof: • The corrugated metal roof is in good condition.

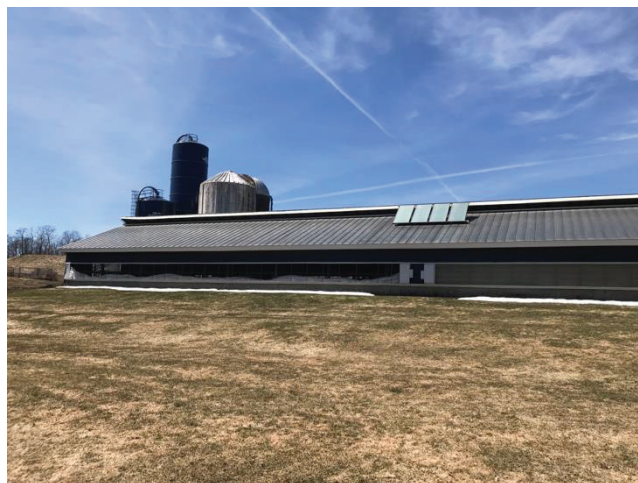
- Structure: Wood roof trusses and timber frame. CMU bearing walls at north wing.
- Foundation: Cast-in-place concrete.
- Walls: CMU bearing walls with FRP or wood paneling at the north wing. The barn is timber frame with wood girts and no interior finish. Corrugated metal siding exterior.
- Roof:
Sloped Roofs: Standing seam metal roof.

USE: This is the largest and Main Barn on the Farmstead and includes a classroom, faculty offices, locker room, milking parlor, milk holding tank room, veterinary rooms and a large heifer barn.

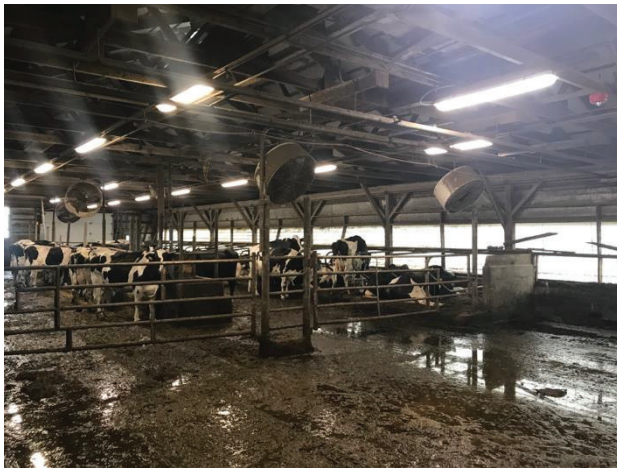
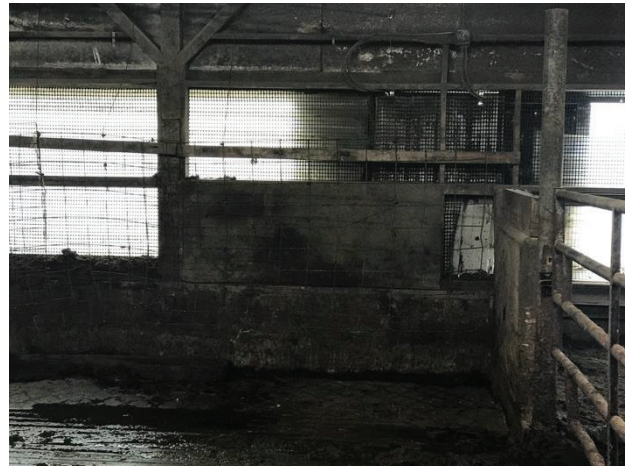
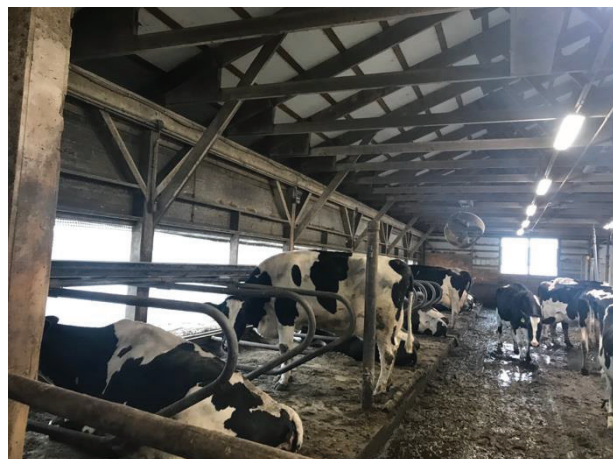
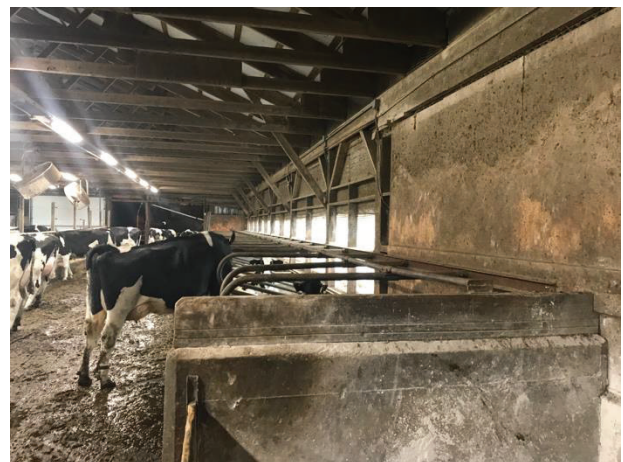
INTERIOR:

- Barn:
 - Heiffer Barn:
 - The heifer stalls that run along both long walls have a concrete floor with steel stall dividers. Steel is rusted in places.
 - The floor along the center of the barn was not exposed. The floor is covered with tar paper and mud.

- The wood trusses appear in good condition. The roof sheathing panels appear in good condition.
 - Steel doors from barn into the milking parlor and veterinary area in the north wing, three pairs of narrow steel doors with closers, are old and worn.

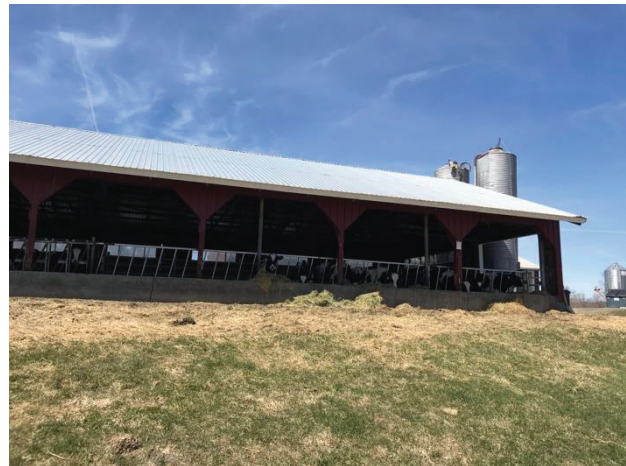
- Structure: Wood /timber frame.
- Foundation: Cast-in-place concrete.
- Walls: Wood timber frame with wood girts and vertical exterior wood board and batten siding.
- Roof:
Sloped Roofs: Corrugated metal roof installed in 2015.

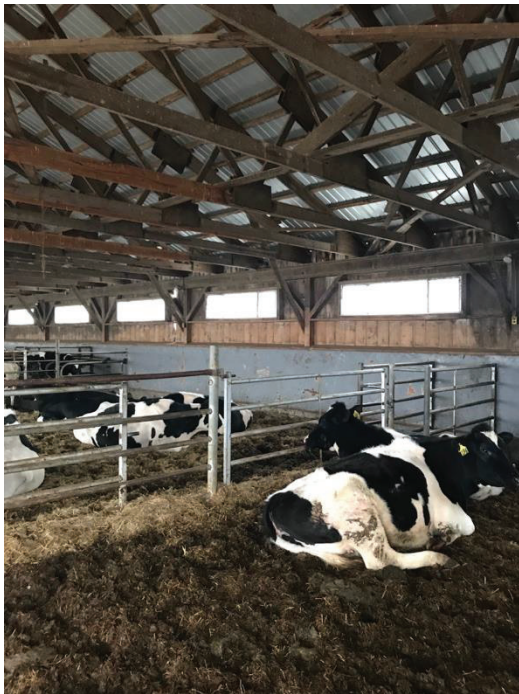
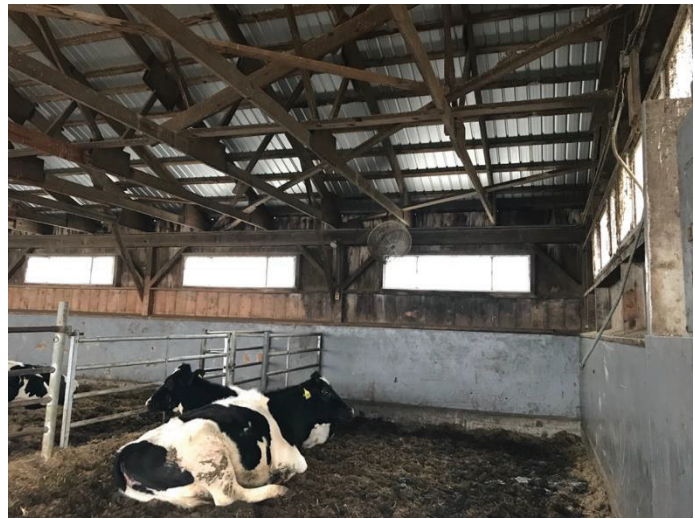
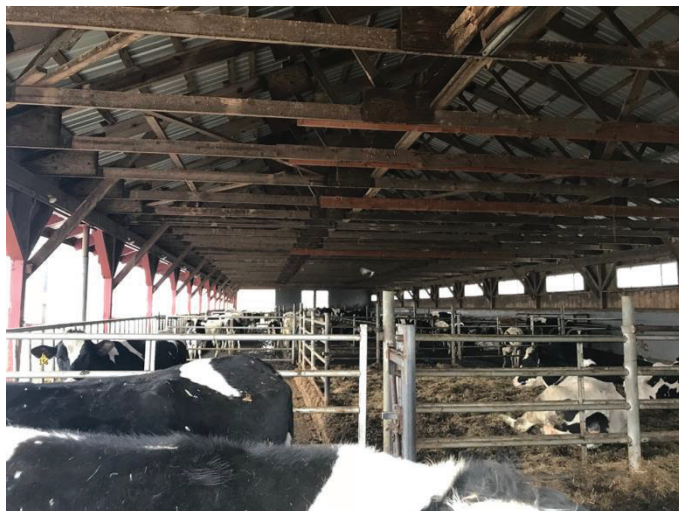
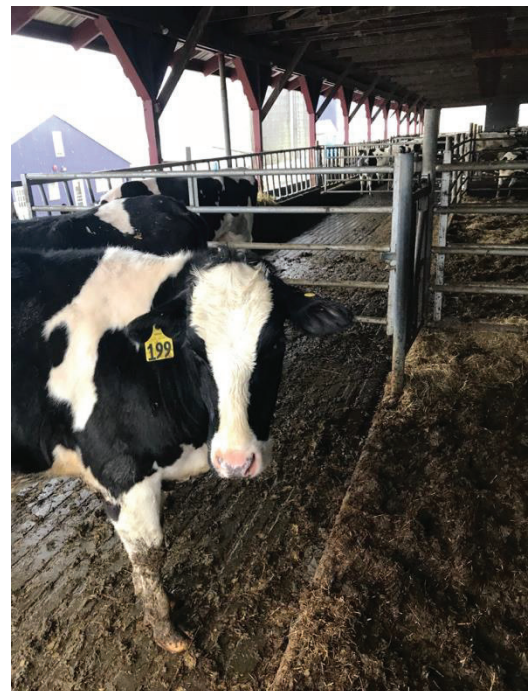
INTERIOR:

- Floor - Concrete and covered in mud and hay.
- Walls - Concrete foundation walls on the North side extend to about 5 feet above the floor. There are no interior wall finishes.
- Ceiling - The wood trusses and flat 2x wood purlins appear sound. No sheathing.

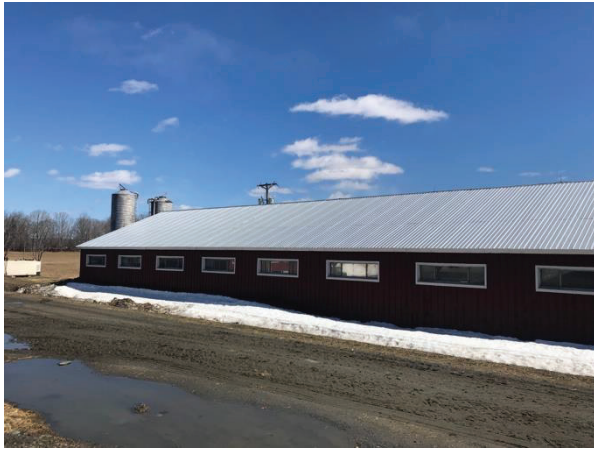
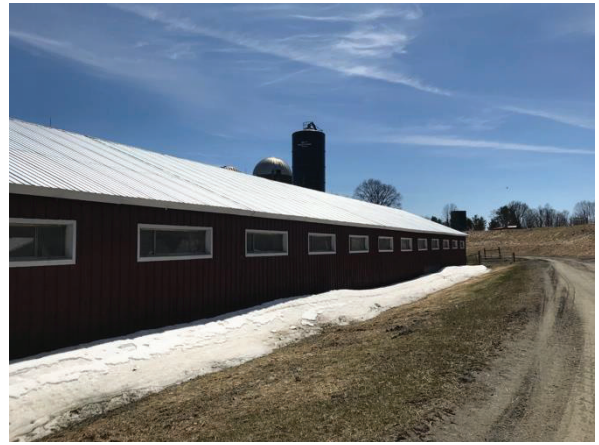
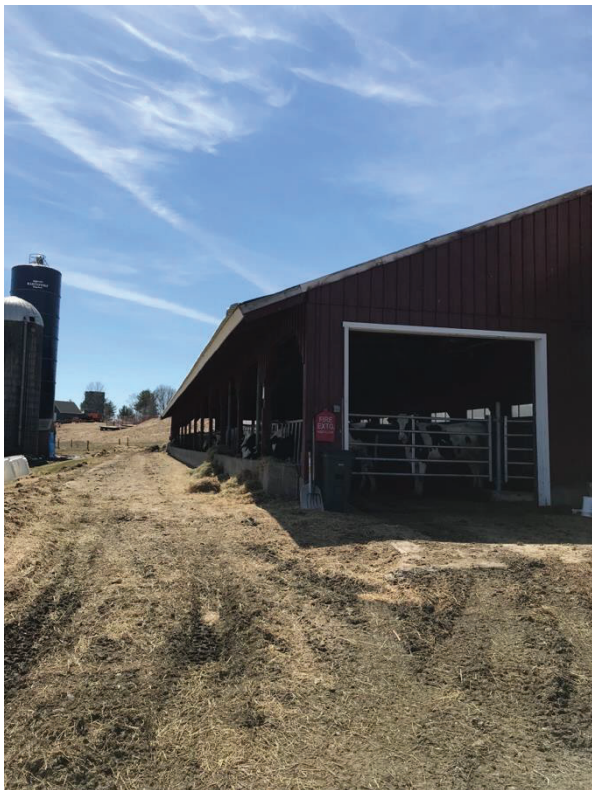
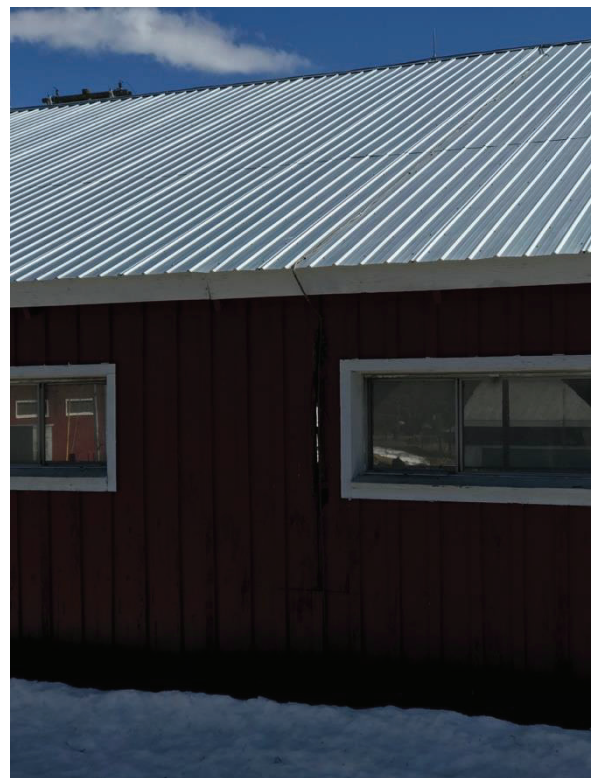
EXTERIOR:

- The exterior vertical wood board and batten siding is in fair condition and appears to have been painted recently. There are some deteriorated boards that should be replaced. Paint on the siding on the west side has begun to peel, paint.
- The wood trim is in fair condition. The north and south trim appears to have been painted recently but the east and west was not. Paint all remaining trim.
- Storm windows are in fair condition. Replace the broken glass pane on the window on the west wall.

- The corrugated metal roof, installed in 2015, is in good condition.

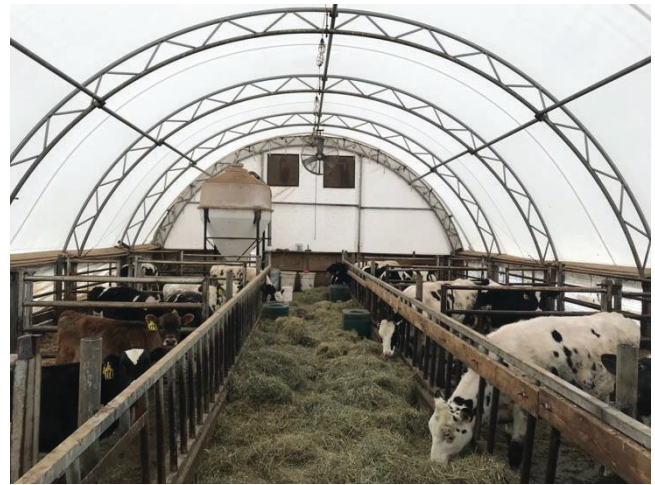
FARMSTEAD • SMALL ANIMAL BARN

- Structure: Wood framed base with aluminum barrel vault trusses and fabric enclosure.
- Foundation: Cast-in-place concrete.
- Walls: Fabric.
- Roof:
Sloped Roofs: Fabric.

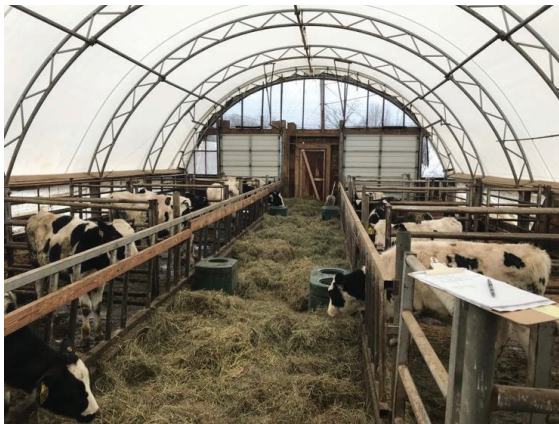
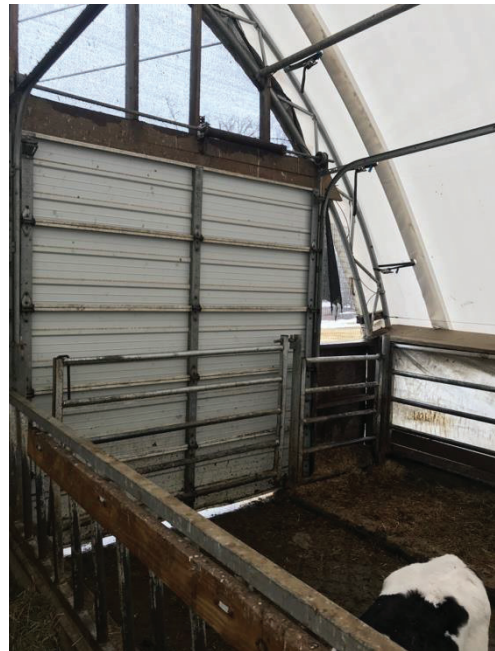
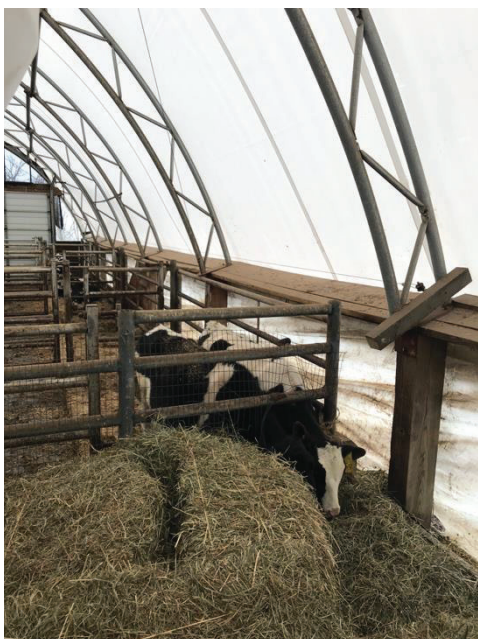
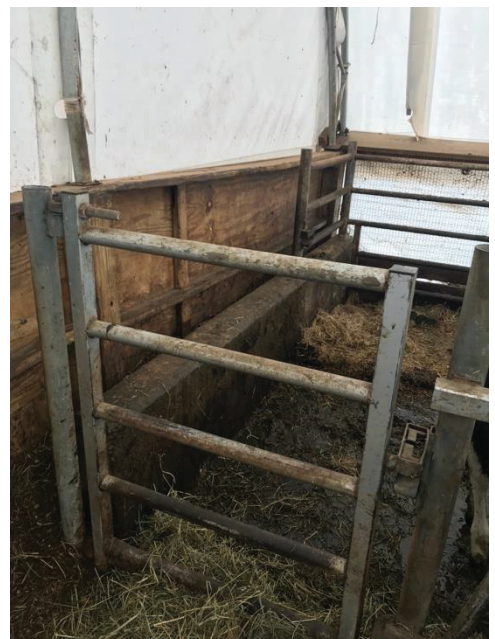
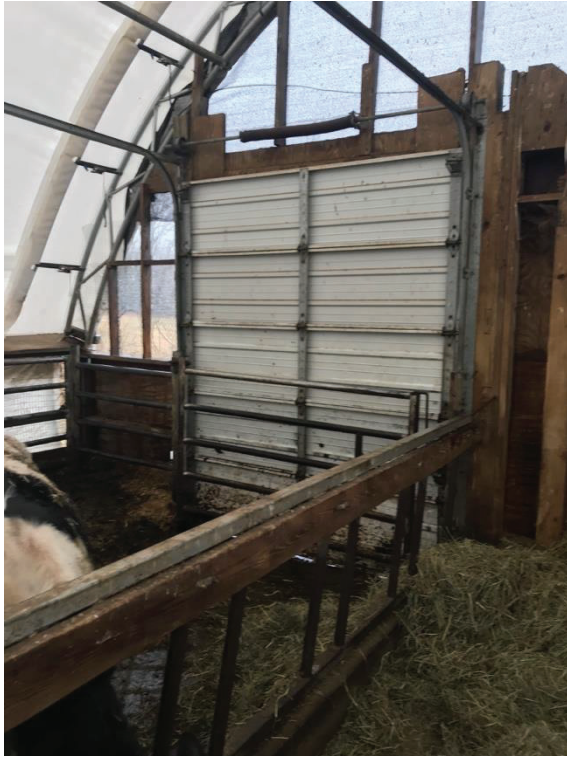
INTERIOR:

- Floor - Concrete and covered in mud and hay.
- Walls - The wood framed end walls are in fair to poor condition. There are no interior wall finishes.
- Ceiling - The aluminum barrel vault frame appears in good condition.
- The overhead doors and tracks are in fair condition on the inside.

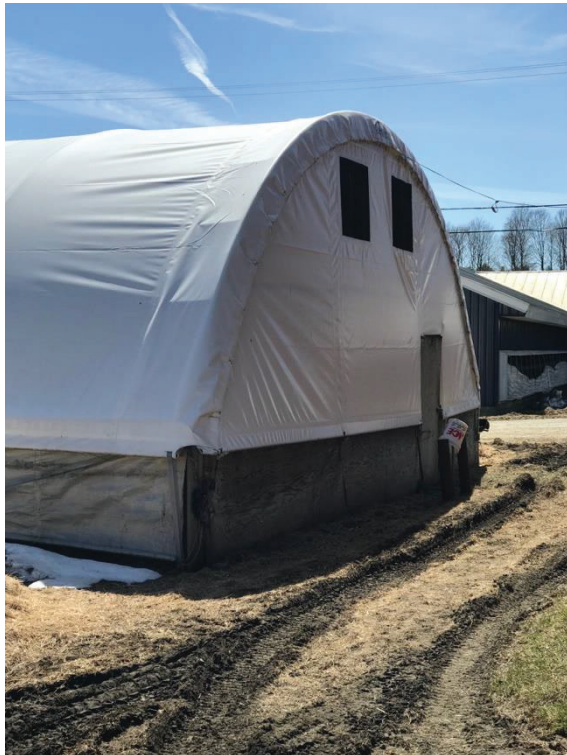
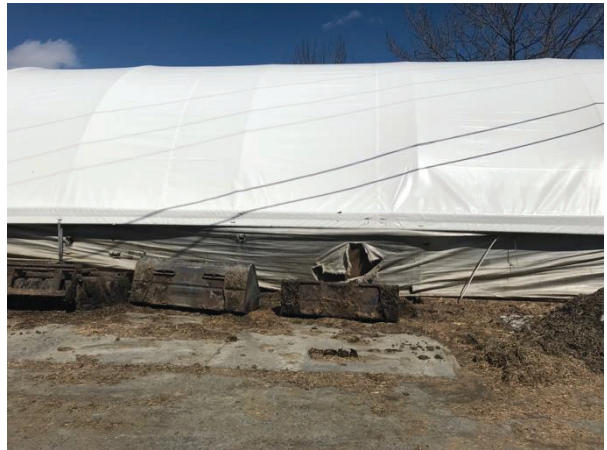
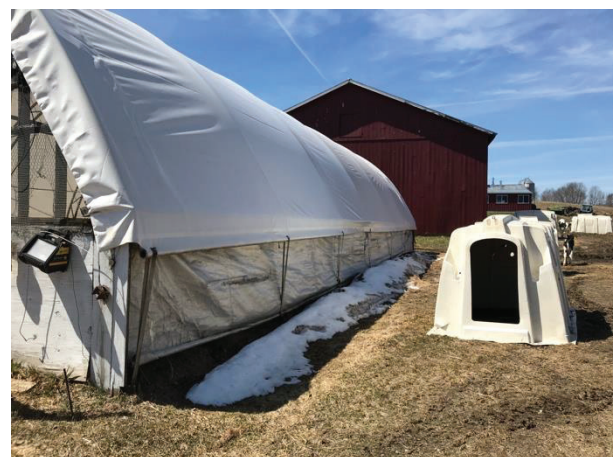
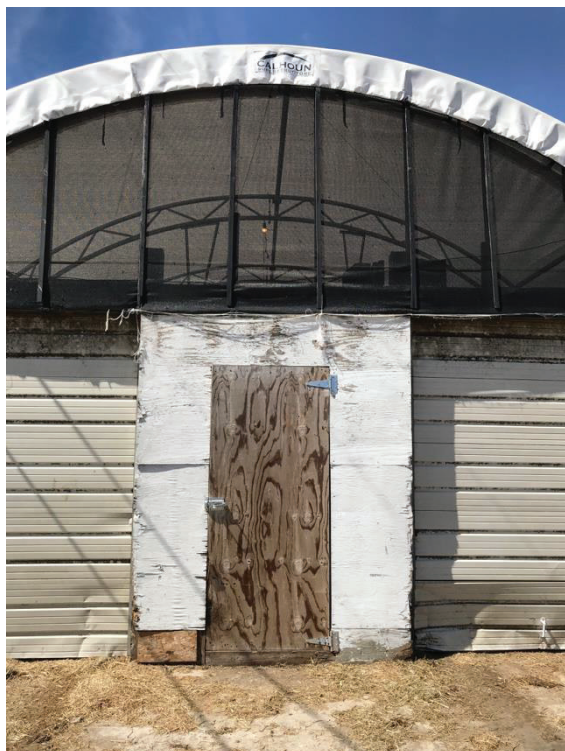
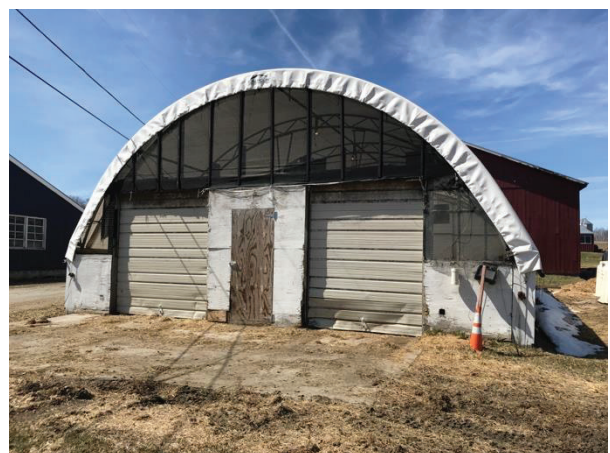
EXTERIOR:

- The fabric on the walls below the barrel vault roof is in poor condition and should be replaced. Replace with more a durable material.
- The wood trim is in poor condition. Replace all wood trim and plywood sheathing at the south end, prime and paint.
- The overhead doors at the south end are in fair to poor condition and the bottom panels are very dented.
- The wood door on the south end is in fair condition, prime and paint the exterior.

- The fabric over the barrel vault roof appears in good condition and looks fairly new.

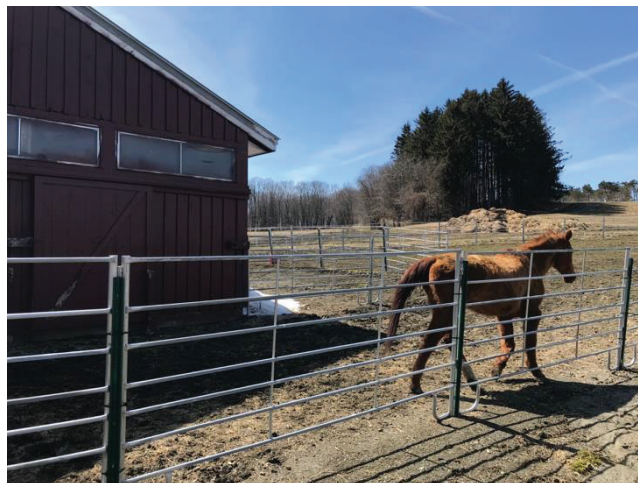
FARMSTEAD • EQUINE VET TECH

- Structure: Wood framing.
- Foundation: Cast-in-place concrete.
- Walls: Wood framed with FRP panels and exterior vertical wood board and batten siding.
- Roof:
Sloped Roofs: Standing seam metal.

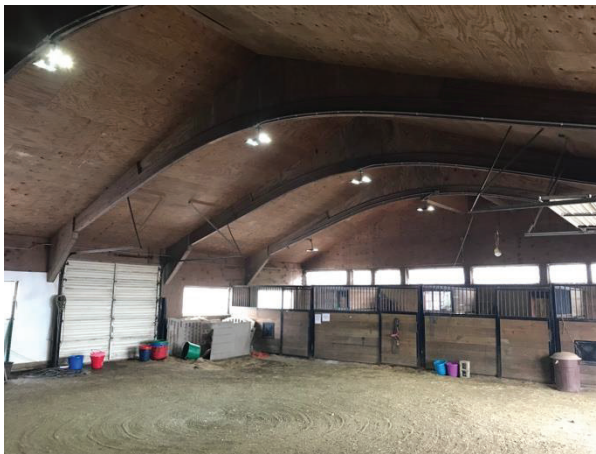
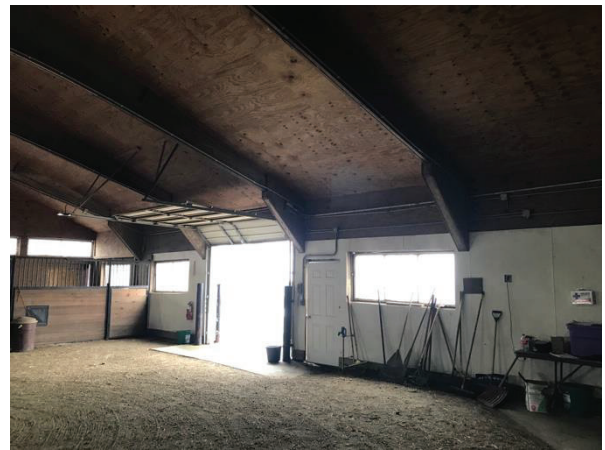
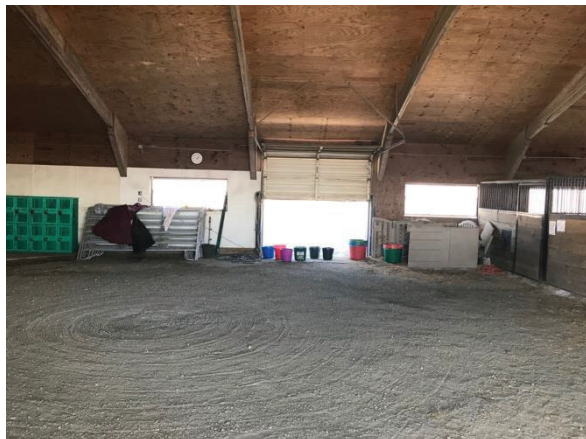
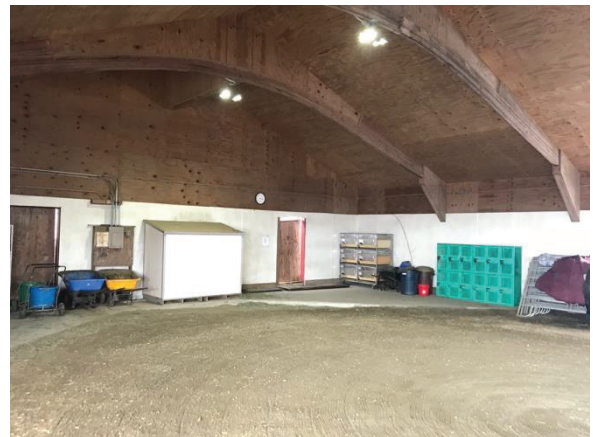
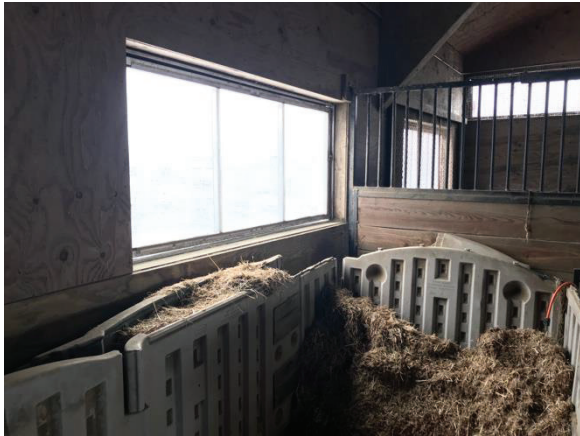
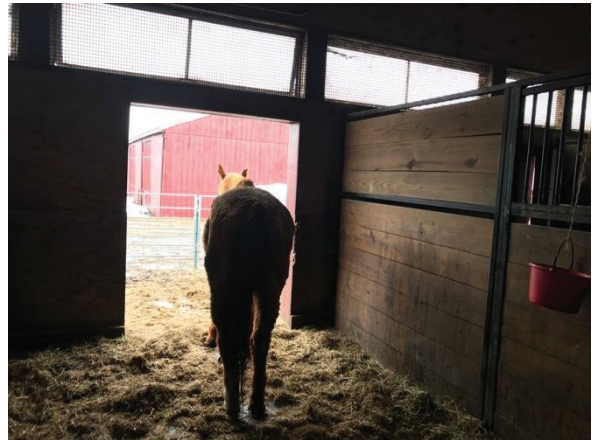
INTERIOR:

- Floor - Concrete at the stalls and perimeter slab are in good condition. Raked dirt floor at exercise arena.
- Walls - FRP panels with unfinished plywood above between the wood glulams.
- Ceiling - Unfinished plywood appears sound. Clear span wood glulam trusses appear sound.
- The wood and metal stall walls and gates are in good condition.

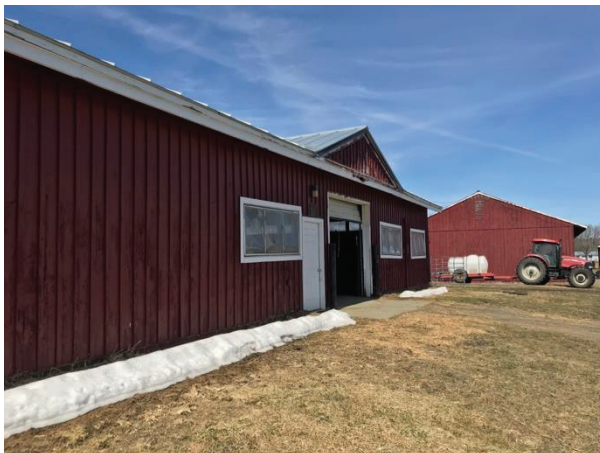
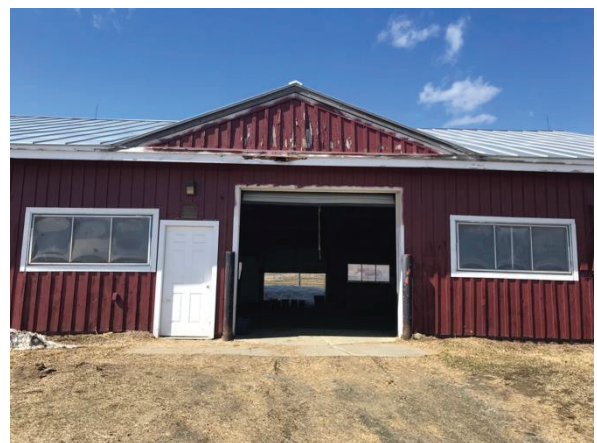
EXTERIOR:

- The exterior vertical wood board and batten siding is in fair condition and appears to have been recently painted. Repair battens on the west side.
- The fixed storm windows are in fair condition. Replace the glass and screen at the damaged window on the north wall.
- The wood trim is in fair condition. The trim has been recently painted at the three windows and one door on the south wall but the remainder of the wood trim needs to be painted. Paint the window and doors casing, eave and rake trim.
- The wood trim and siding at the gable dormer above the south entry doors is deteriorated. Repair, scrape and paint.
- The overhead doors are in good condition. Clean.
- The door on the south wall is in good condition, install weather seals.

- The sliding wood barn doors on the west wall are in fair to poor condition. Repair and adjust for proper operation.
- The sliding wood barn doors on the east wall are in fair condition.

- The standing seam metal roof is in good condition.

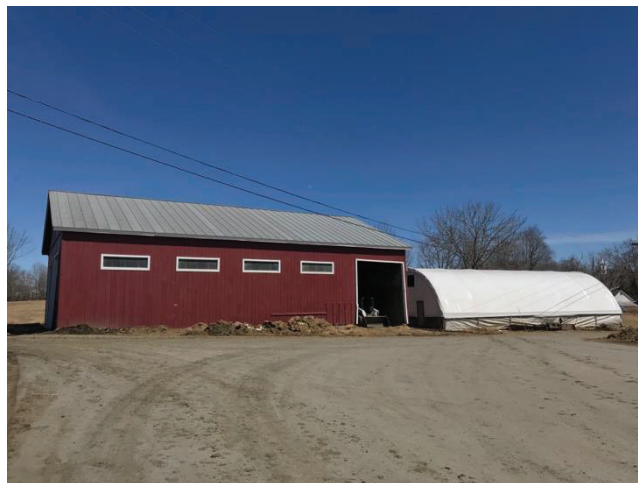
- Structure: Wood frame.
- Foundation: Cast-in-place concrete w/ curb.
- Walls: Wood frame with exterior vertical wood board siding.
- Roof:
Sloped Roofs: Standing seam metal.

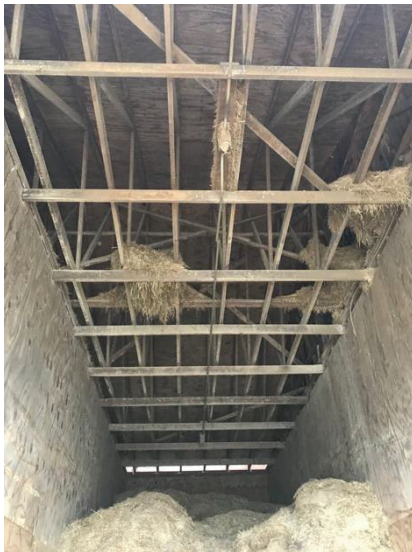
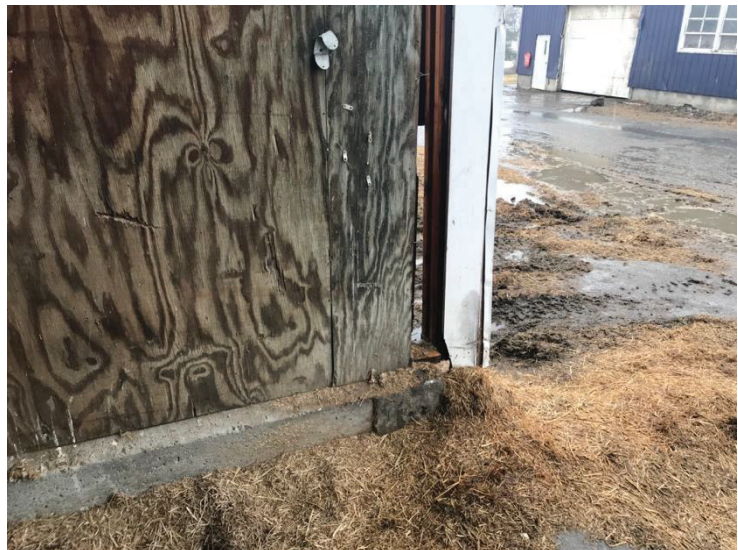
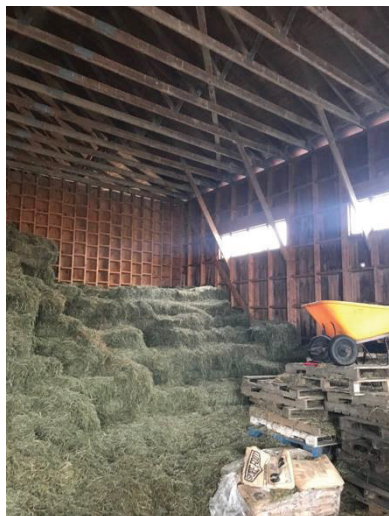
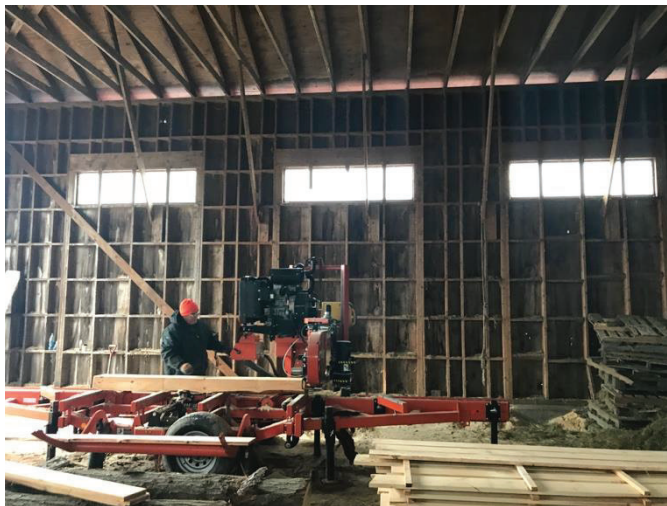
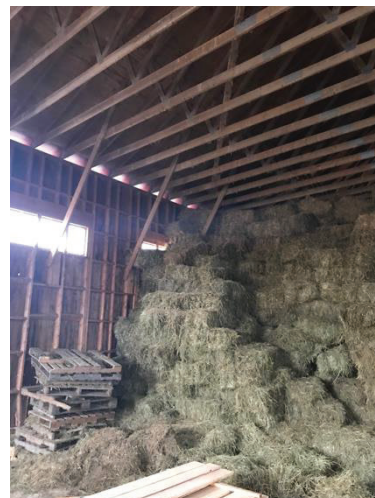
INTERIOR:

- Floor - Concrete in good condition.
- Walls - There are no interior wall finishes.
- Ceiling - The wood trusses and plywood sheathing appear sound.

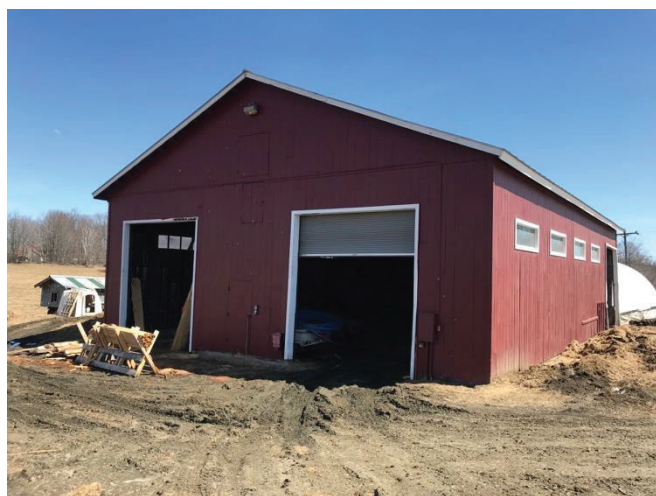
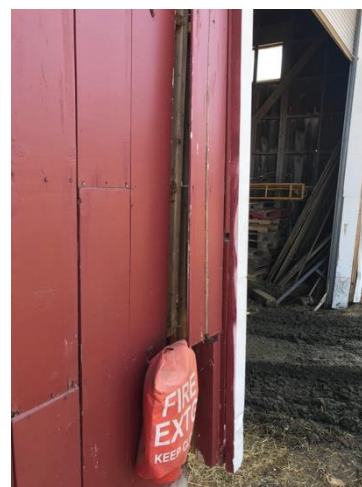
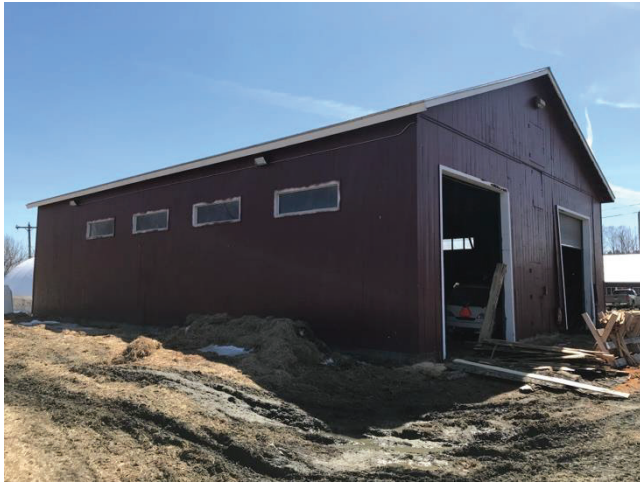
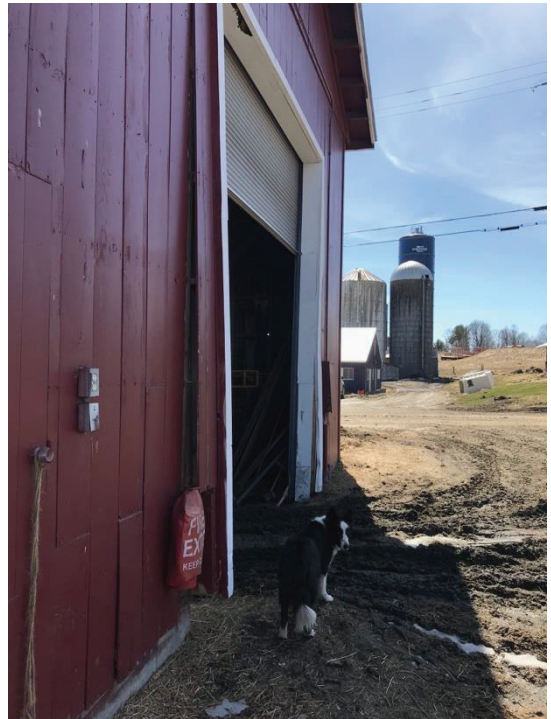
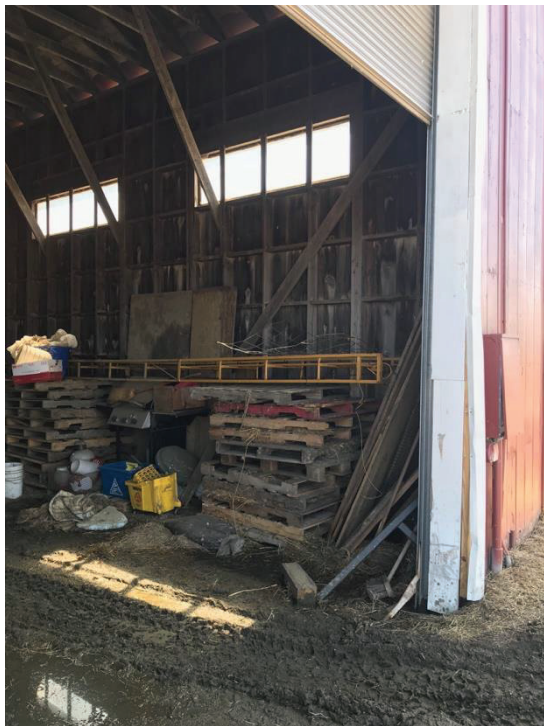
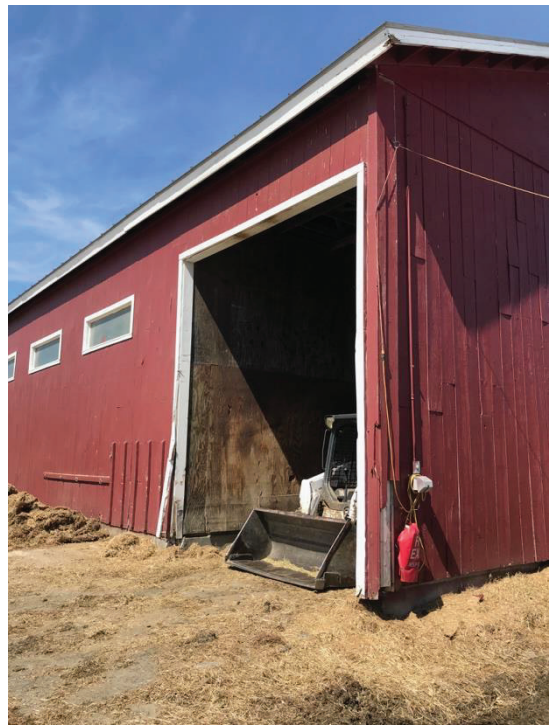
EXTERIOR:

- The exterior vertical wood board siding is in fair condition and appears to have been recently painted. Some of the boards on the west and south sides have pulled away from the framing, reattach.

- The fixed windows are in fair condition.
- The wood trim is in fair condition on the west side and appears to have been recently painted. The wood trim on the north and west sides needs to be painted.

- The two large overhead coiling doors on the North end are in good condition. The wood frame and casings at the heads and jambs are damaged. Replace damaged trim and repair remainder as required and paint.

- The wood frame and casing at the jambs of the large opening on the west side is damaged. The siding at the southwest corner adjacent to this opening is also damaged. The framing at the bottom of this corner is deteriorated. Repair framing. Replace damaged trim and repair remainder as required and paint.

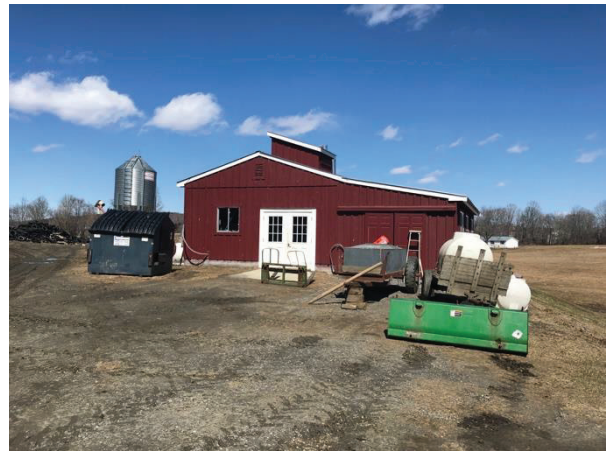
- Structure: Wood frame.
- Foundation: Cast-in-place concrete w/ curb.
- Walls: Wood frame with exterior vertical wood board and batten siding.
- Roof:
Sloped Roofs: Corrugated metal.
