Facilities Conditions Assessment

KEENAN HALL

CONSTRUCTED: 1967

LAST RENOVATED: 1999

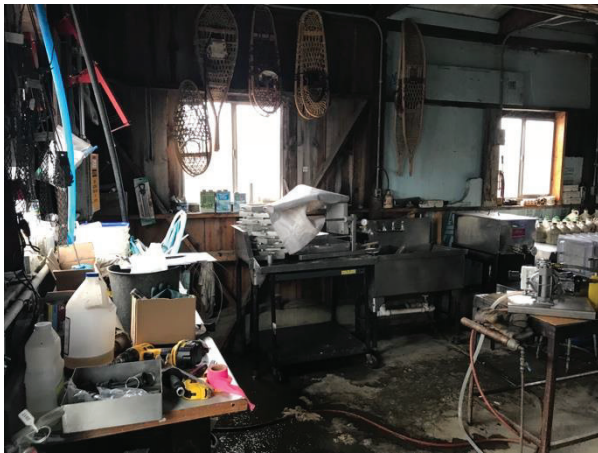
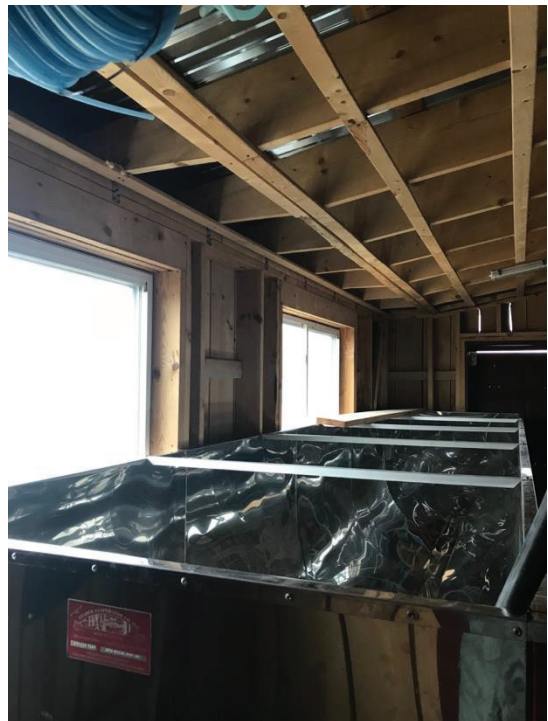
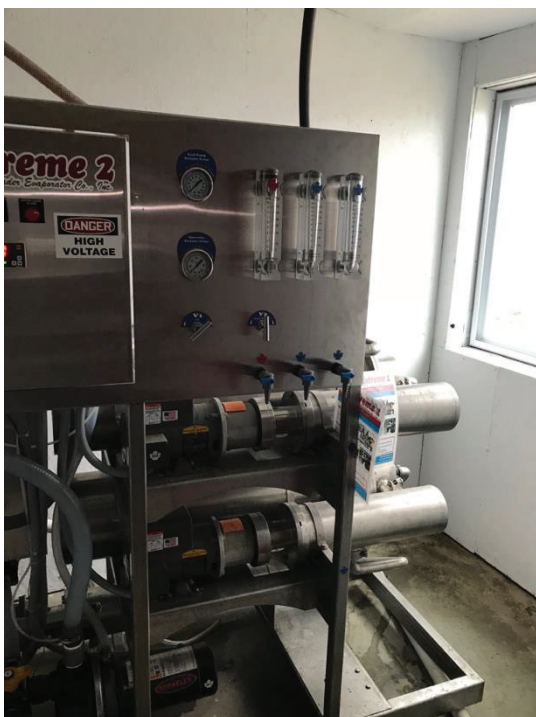
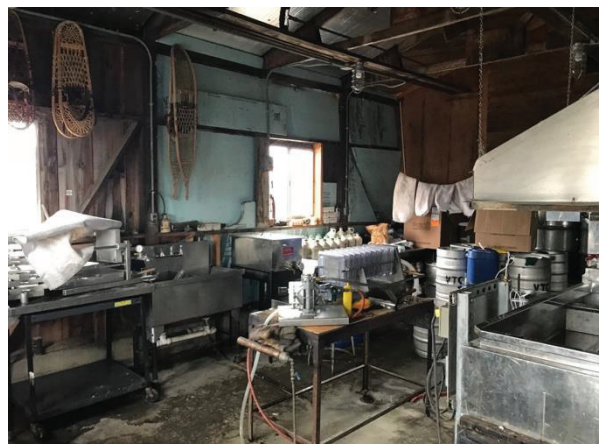
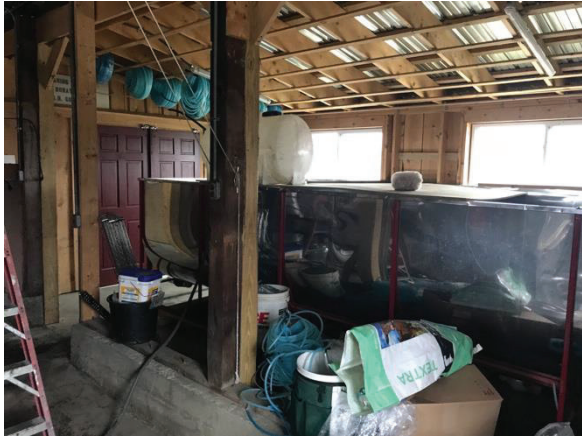
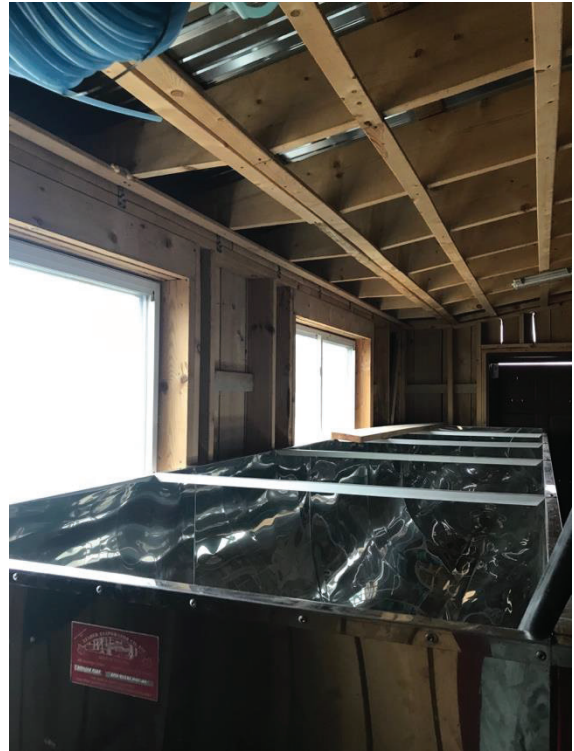
INTERIOR:

- Floor - Concrete in good condition.
- Walls - There are no interior wall finishes.
- Ceiling - The wood trusses and flat 2x wood purlins appear sound. No sheathing.

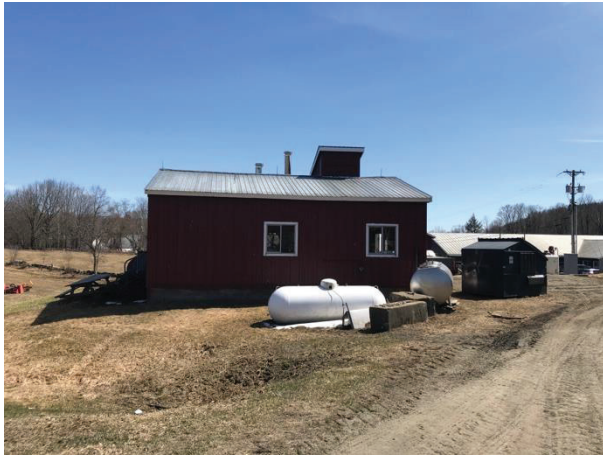
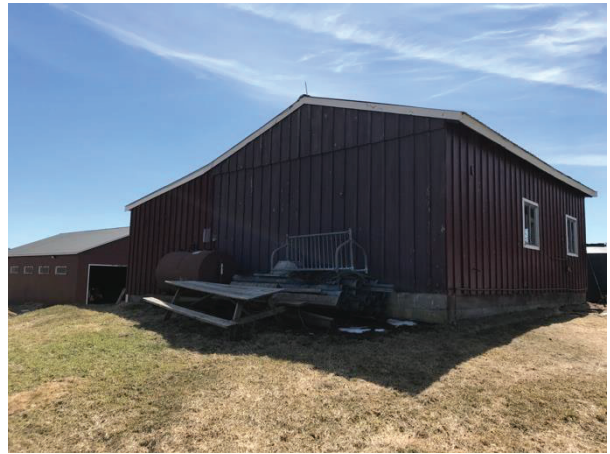
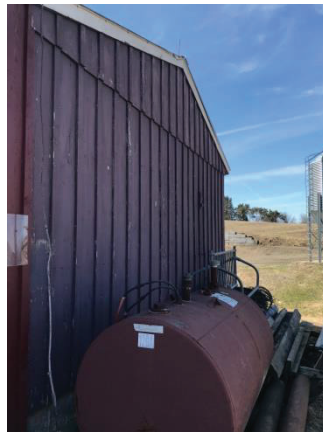
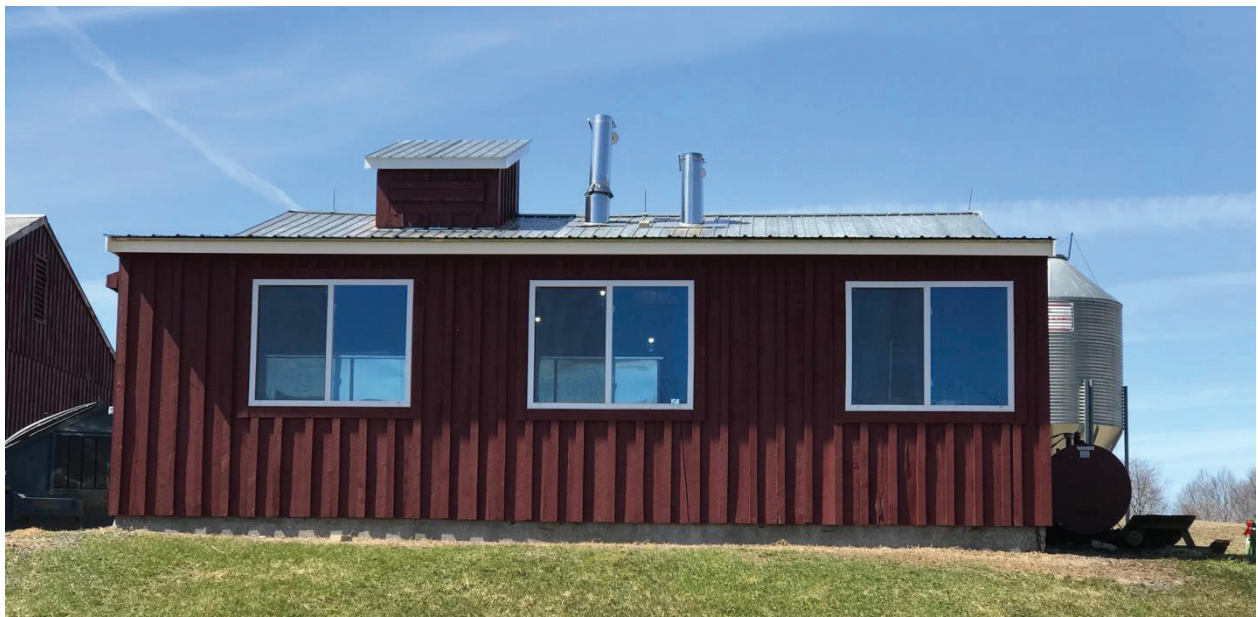
EXTERIOR:

- The exterior vertical wood board and batten siding is in good condition and appears to have been painted recently. The paint on the east side is beginning to peel. Paint the east wall.
- The doors and windows are in good condition.
- The wood trim is in good condition and appears to have been painted recently. The paint on the east side is beginning to peel. Paint the trim on the east side.

- The corrugated metal roof is in good condition.

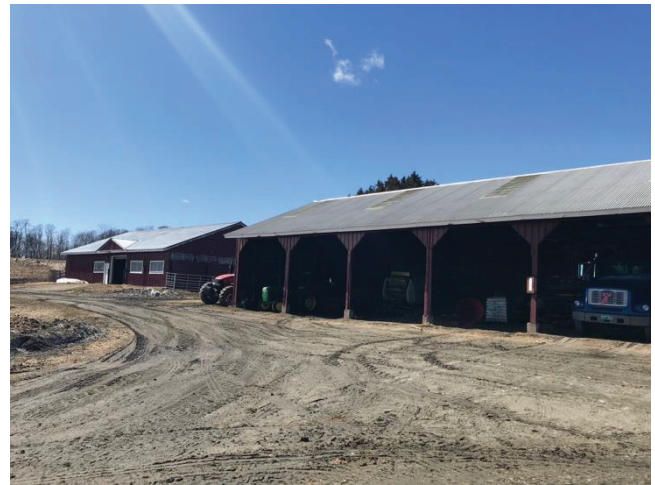
- Structure: Wood /timber frame.
- Foundation: Cast-in-place concrete.
- Walls: Wood timber frame with wood girts and vertical exterior wood board and batten siding.
- Roof:
Sloped Roofs: Corrugated metal roof

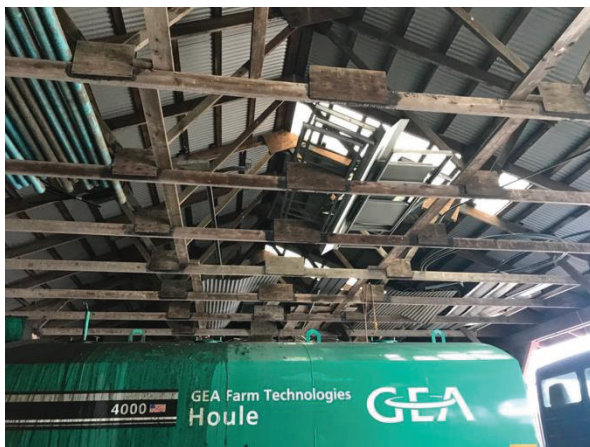
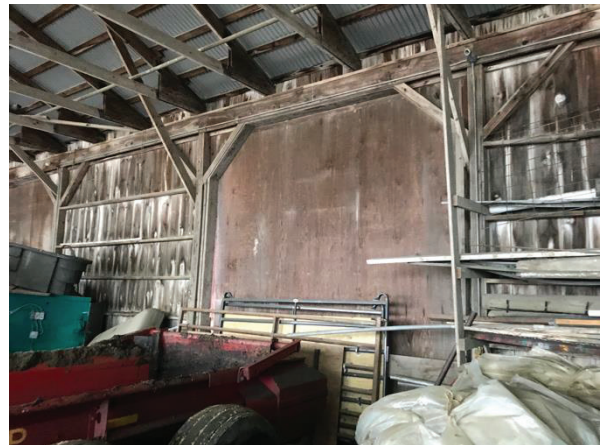
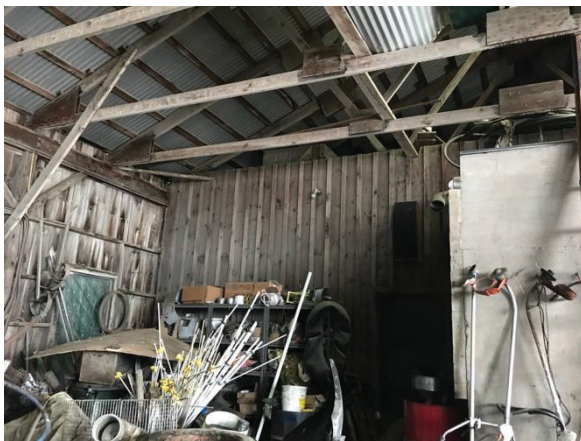
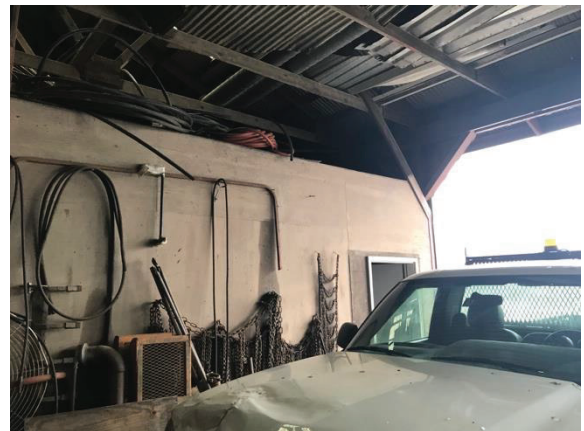
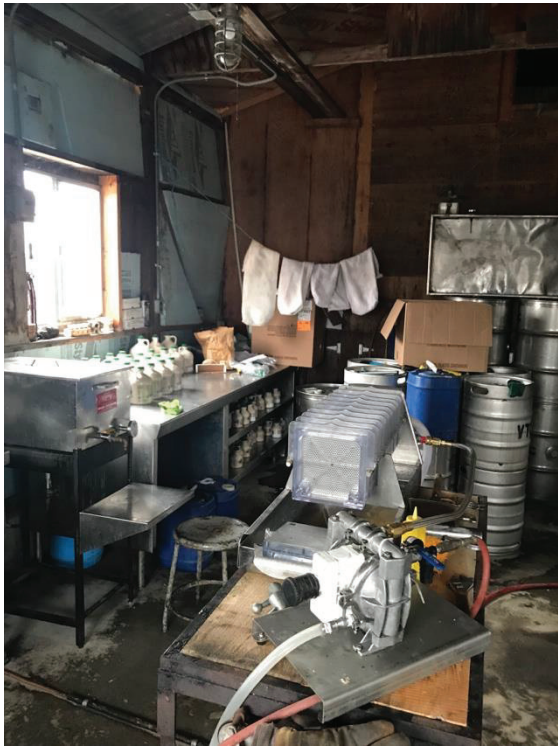
INTERIOR:

- Floor - Concrete in good condition.
- Walls - There are no interior wall finishes.
- Ceiling - The wood trusses and flat 2x wood purlins appear sound. No sheathing.

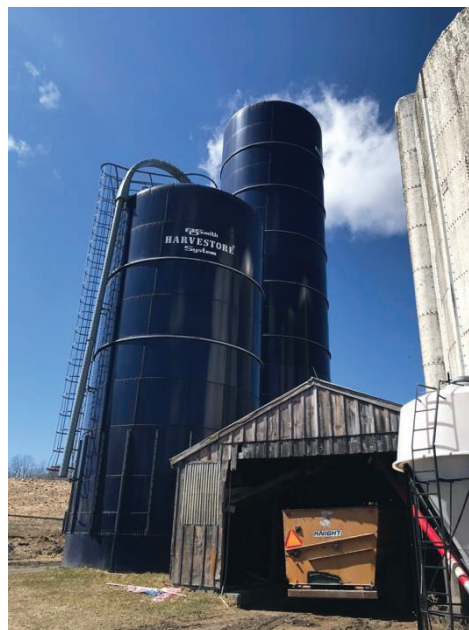
- Structure: Wood frame.
- Foundation: Cast-in-place concrete.
- Walls: Wood frame with exterior vertical wood board and batten siding.
- Roof:
Sloped Roofs: Corrugated metal.

- Floor - Dirt.
- Walls - There are no interior wall finishes. The wood framing appears sound with some deterioration noted at the foundation. Further analysis of the structure is required to determine if it's worth saving.
- Ceiling - The wood rafters and flat 2x wood purlins appear sound. No sheathing.

- The exterior vertical wood board and batten siding and wood trim at the shed is in very poor condition and should be replaced entirely if the structure is determined to be sound.
- Windows in the shed are in very poor condition and should be replaced.

Roof: • The corrugated metal roof at the shed is in very poor condition and should be replaced entirely if the structure is determined to be sound.
